# Manhole Inspection Summary

Manhole # S15KK1032MH

Insp Date: **6/18/07 10:49 AM**

**Location** Address: **2814 PACKARD RD**

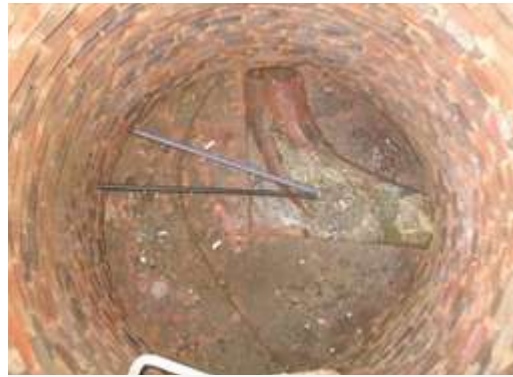
Top View

Evidence of surcharge - Bench debris.  
Channel debris.

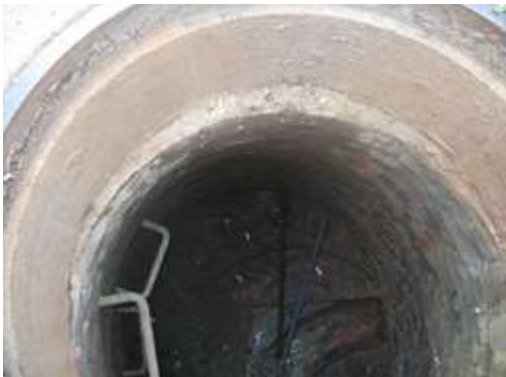
Defect

**Frame** Offset: **1** (in.) Condition: ☐ Sound ☐ Cracked ☒ **Leaks**

Condition: ☐ Sound ☐ Cracked ☐ Root Intrusion ☐ Loose Brick ☒ **Deteriorated**

Infiltration: ☐ None ☒ **Joint** ☐ Cracks ☐ Mortar ☐ Roots ☒ **Wall**

Frame leaks. Frame offset. Adjustment  
deterioration and infiltration. Barrel  
infiltration.

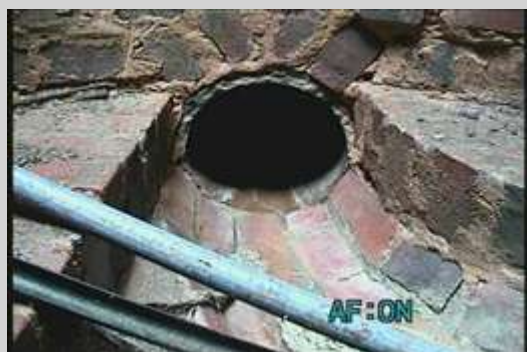
Pipe Out @ 12 O'Clock

Infiltration: **Evidence** Pipe Seal Cond: **Unknown**

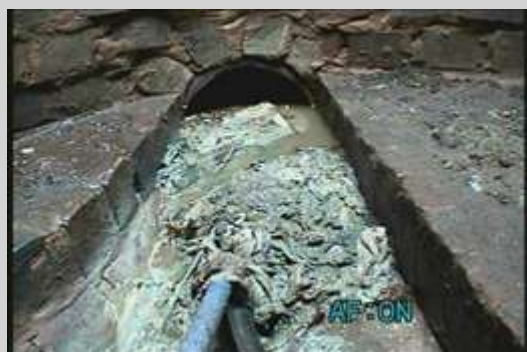
Pipe In @ 3 O'Clock

Channel debris.

Deposits: ☐ None ☒ **Mud** ☐ Sludge ☒ **Debris** ☐ Grease

Silt Depth: **4** (in.) Deposits Extent: **Heavy**

Infiltration: **Evidence** Pipe Seal Cond: **Cracked**
